AWT 1897_2 TEST REPORT APPLICATION SERVICE DEPARTMENT

Fogging test according to EN 1279.6

“Film in Spacer” Insulating Glass

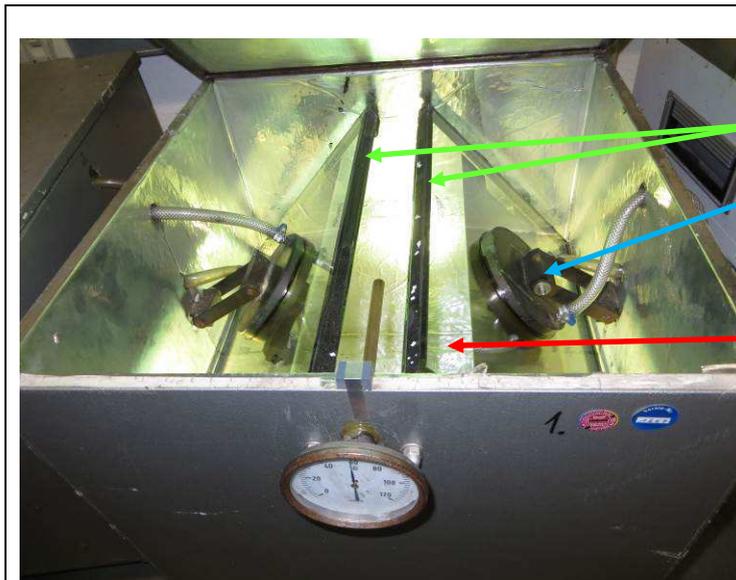
Example photo

Test assembling:

Test units

Cooling plate

Ultra-Vitalux 300W
(covered)

The release of gaseous substances is achieved by applying heat at a point on the relevant organic component. Condensation is achieved by cooling a spot of the glass surface. After exposure, the test pieces are visually inspected for evidence of fogging on the interior glass surface.
